Department of Historic Resources
Reconnaissance Level Survey

Isle Of Wight *DHR Id#: 046-0092*

Property Name(s): ..... Jones House {Historic}
Property Date: 1770
Address(s): ..... Route 626 {Current}
County/Independent City: Isle Of Wight
City: ....
State, Zip: .....Virginia
USGS Quad Name: ..... RUNNYMEADE

3.4.78 JONES HOUSE (46-92), RT. 626, ISLE OF WIGHT Co.

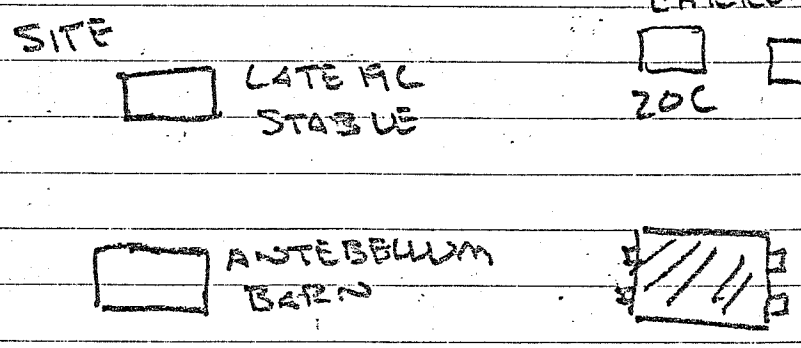
LATE 18C (A)
LATE 18C/EARLY 19C (C; LEANTO ROOF)
EARLY 19C (B, D; PRESENT ROOF, CHIMNEYS, U.P.)
